# 737 GRAPHITE COMPOSITE FLIGHT SPOILER FLIGHT SERVICE EVALUATION

FIRST ANNUAL REPORT  
JULY 1973 THROUGH MARCH 1975

Prepared under contract NAS1-11668 by  
BOEING COMMERCIAL AIRPLANE COMPANY  
P.O. Box 3707  
Seattle, Washington 98124

May 1975

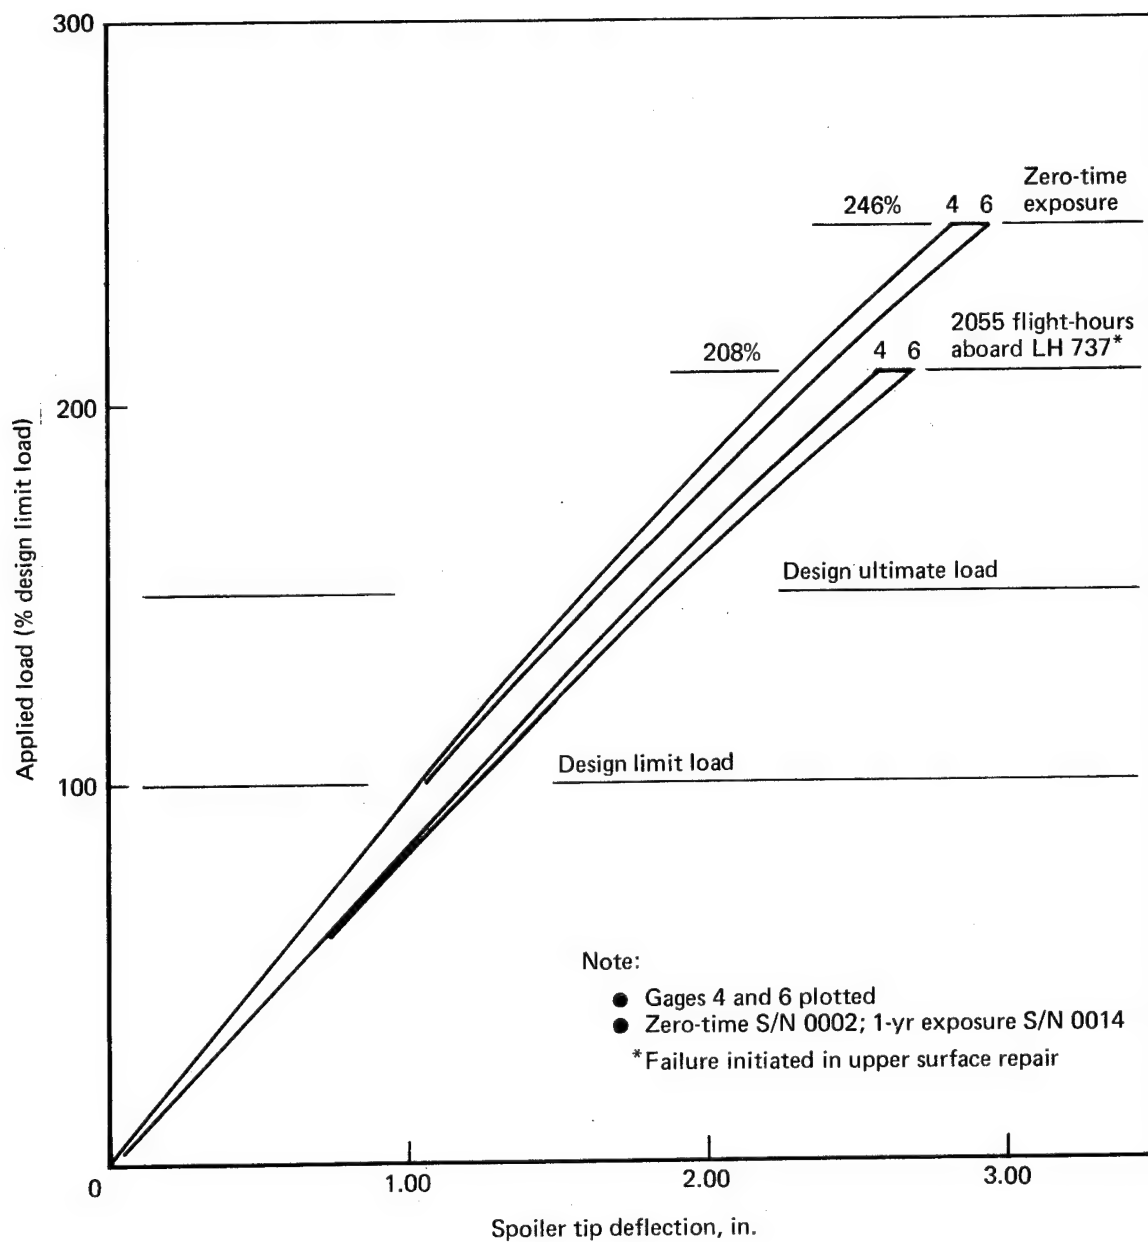
Figure 8.—Load-Deflection Curves—Zero-Time and 1-Year Exposure  
(Union Carbide T300/2544 Material System)

The static test setup from the original certification testing was used to conduct these tests. All three tests were conducted on the same working day. Test results are plotted in figures 8, 9, and 10, with the corresponding plots of the certification testing included in each figure. Failure load levels of the current tests are considered satisfactory since they equal or exceed the values achieved by the production aluminum spoiler (ref. 1, Third Quarterly Report, April 1973). Photos of the failed test spoilers are shown in figures 11, 12, and 13.

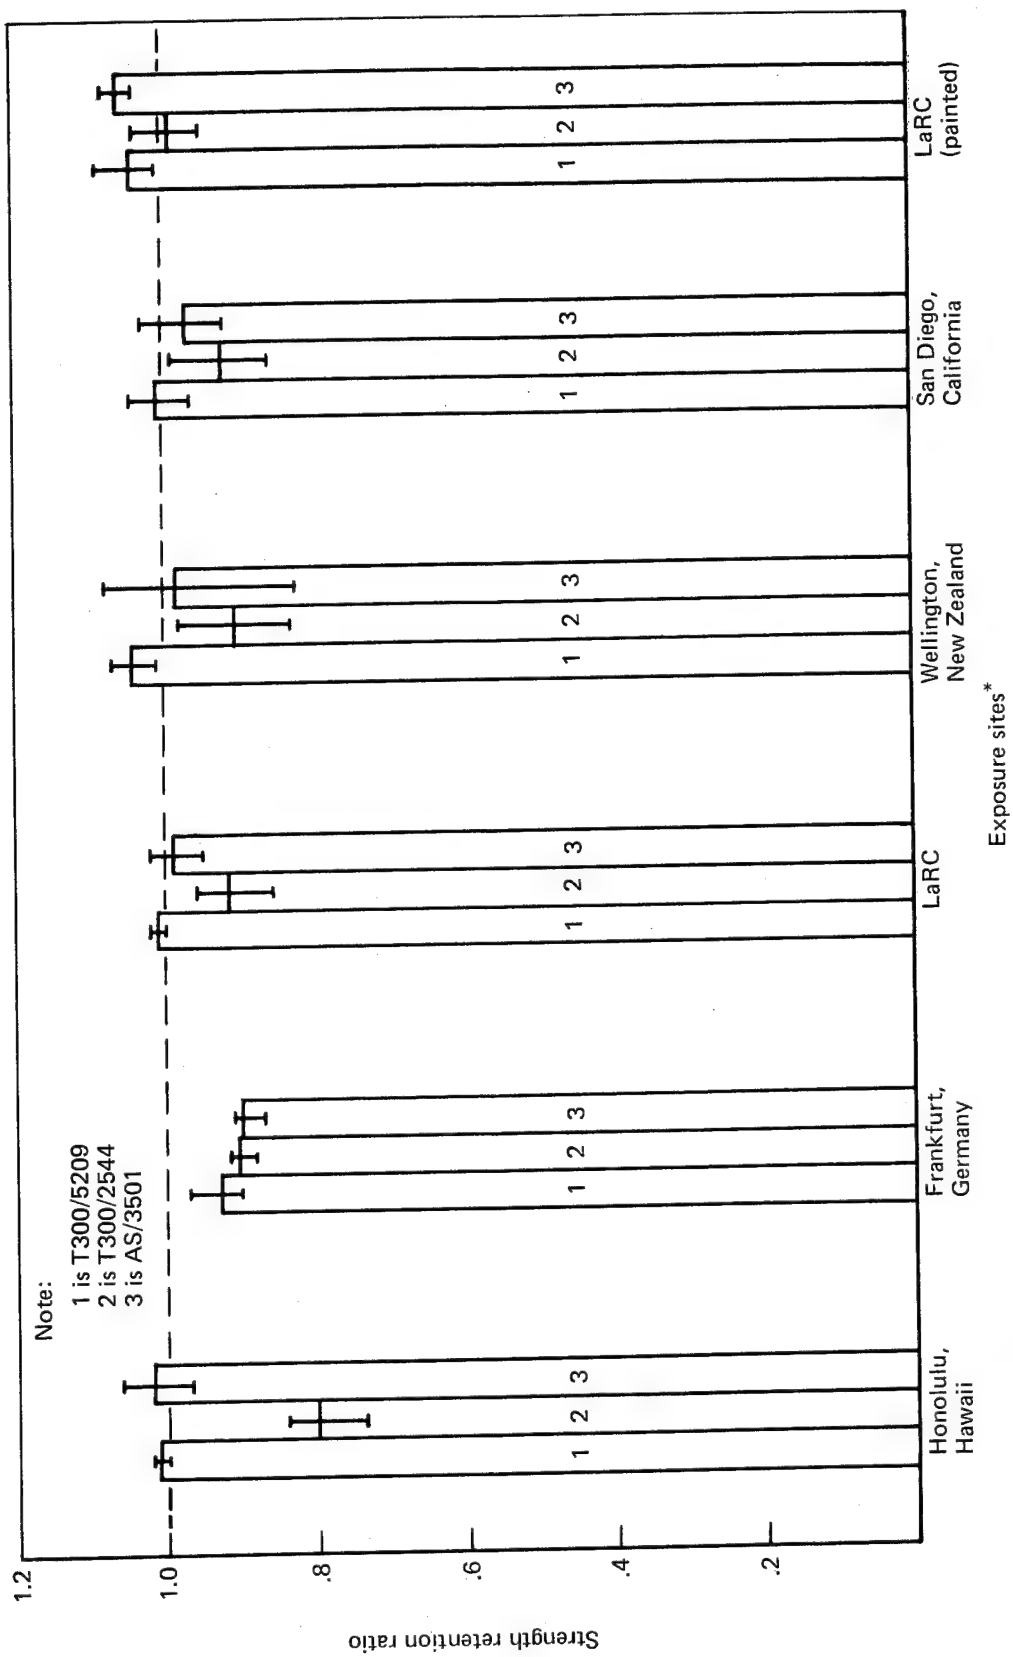
Figure 19. — Interlaminar Shear Strengths of Graphite-Epoxy Composites After 1-Year Outdoor Ground Exposure

Tables 6, 7, and 8 give results of tests on shear, flexure, and compression specimens of the three graphite-epoxy material systems following 1 year of environmental exposure at five of the six sites. Comparisons with the test results on unexposed baseline specimens are made in the bar graphs of figures 19, 20, and 21. These three material systems show generally less than 10% change in mechanical properties. Moisture pickup by these materials has been generally less than 1% based on changes in specimen weight. Although the change in material properties is about the same order of magnitude as the change in static strength and stiffness of the spoilers, neither is large enough to be significant by itself. The overall effects of the first year of the outdoor exposure program are summarized in table 9.
